# **Assessment of Dam Safety of Coal Combustion Surface Impoundments**

**Indianapolis Power & Light Company**

**Eagle Valley Generating Station**

**November 15, 2010**

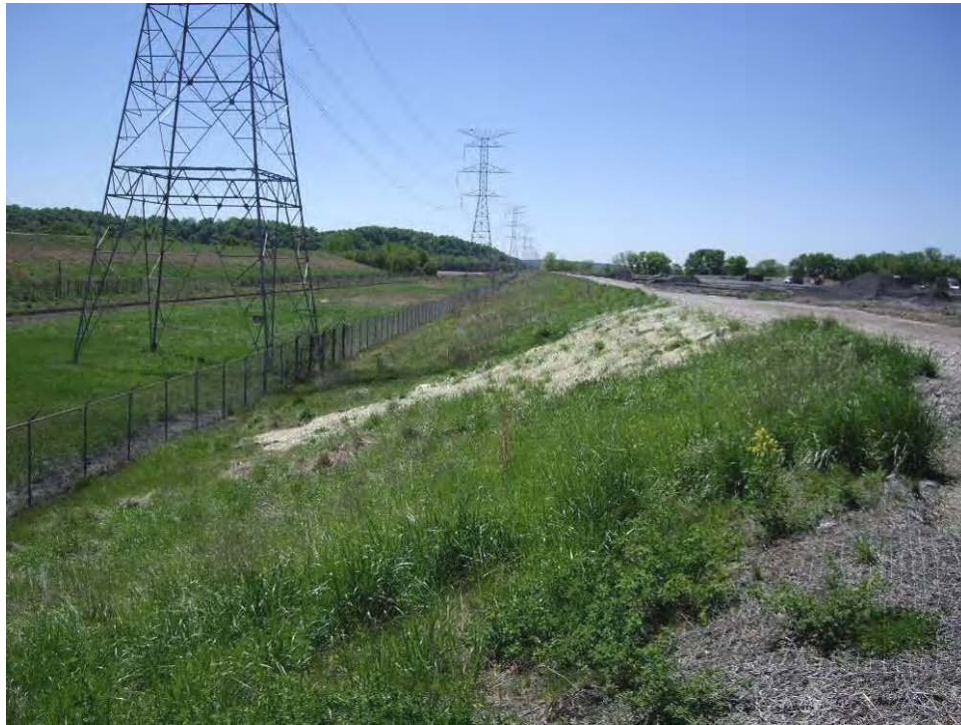
The exterior slopes of the Pond A embankments appear to be in fair condition. The exterior slopes on the north, south, east, and west embankments ranged from approximately 2.5H:1V to 3H:1V (Photos 1, 15, 20, 23, 25, 45, and 46). The exterior slope on the embankment between Pond A and Pond B (divider embankment A/B) and embankment between Pond A and Pond C (divider embankment A/C) ranged from approximately 2H:1V to 3H:1V (Photos 28, 33, 34, 38, 40, and 42).

1. Pond A – East embankment exterior slope looking south.

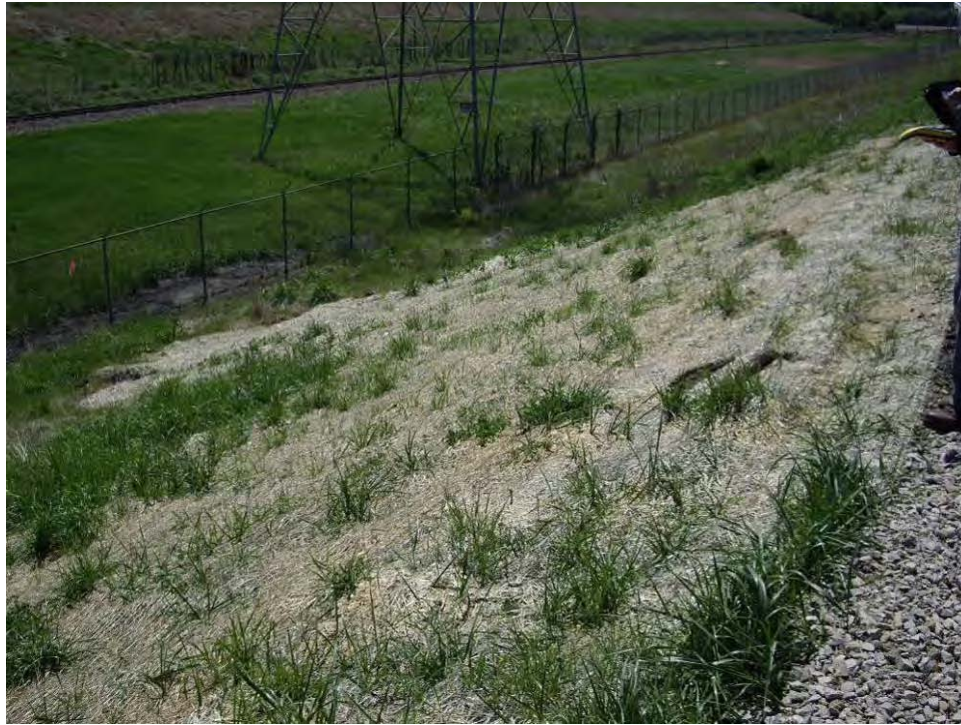
One repair on the northeast corner of the east embankment was observed (Photos 1, 3, and 4). IPL indicated that the repair was needed due to an ash sluice line leak located in the northeast corner of Pond A. The repair consists of an erosion control blanket. The erosion control blanket did not appear to be installed consistent with typical manufacturer's recommendations. Stakes did not appear to be installed properly, and the blankets were not overlapped or keyed into an anchor trench in the slope. Approximately 1- to 3-inch gaps were observed below the blanket.

3. Pond A – East embankment exterior slope. Erosion control blanket installed near northeast corner looking southeast. Note: Blanket appears to be improperly staked, there are 1- to 3-inch gaps beneath the blanket, and there is no apparent anchor trench or roll overlap.

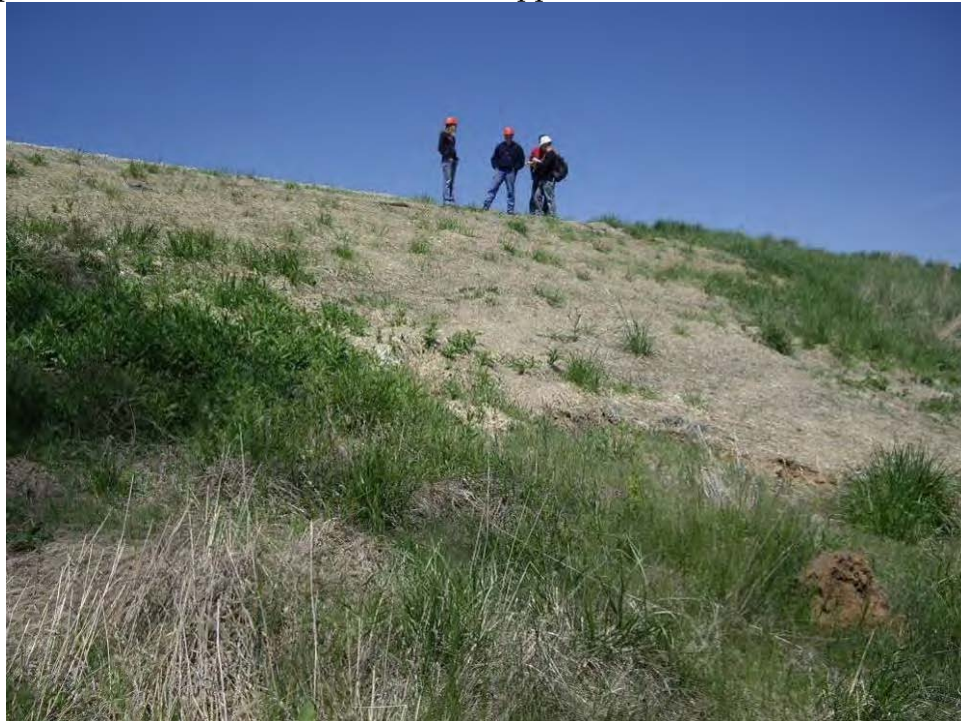
4. Pond A – East embankment exterior slope. Erosion control blanket installed near northeast corner looking northwest.

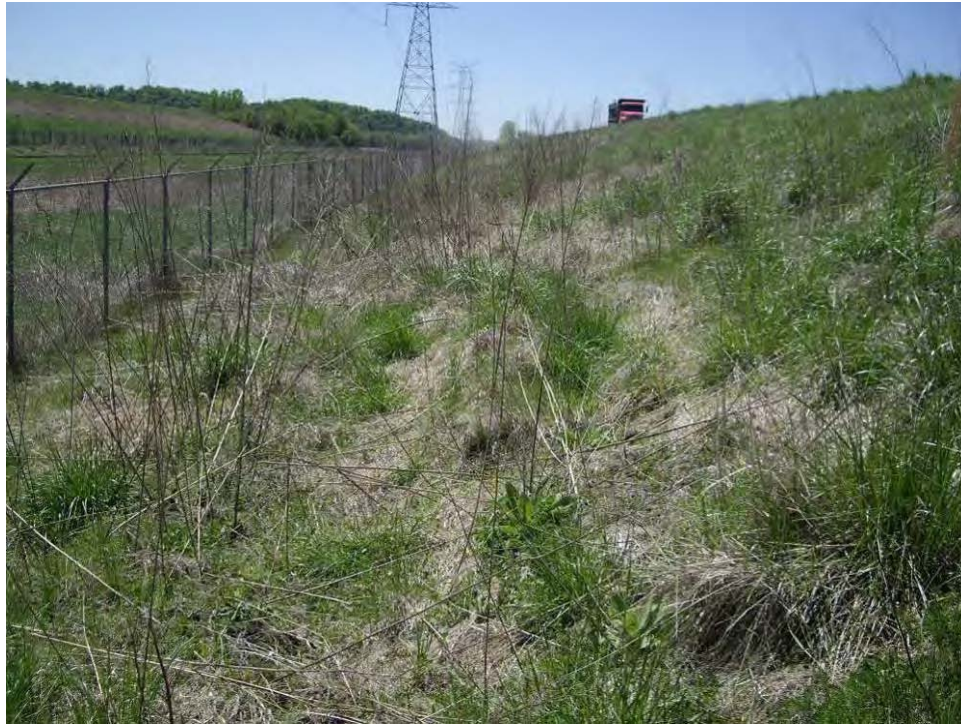
There were two low spots at the toe of the east embankment (Photo 5). At the low spots, there was also some minor sloughing. IPL stated these were low areas where a tractor had previously gotten stuck during mowing operations. A surface depression was also observed near the crest of the eastern embankment (Photo 7).

5. Pond A – East exterior slope looking south. Low spot and minor slough at toe of slope.. Possible tractor rutting.

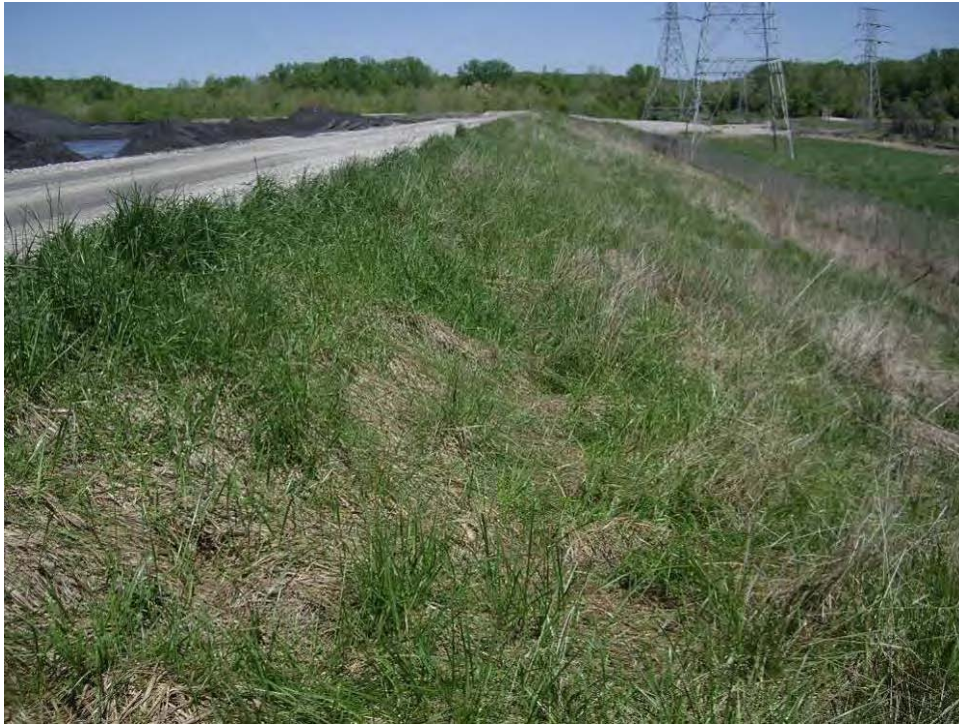
7. Pond A – depression near crest of east embankment, looking north.

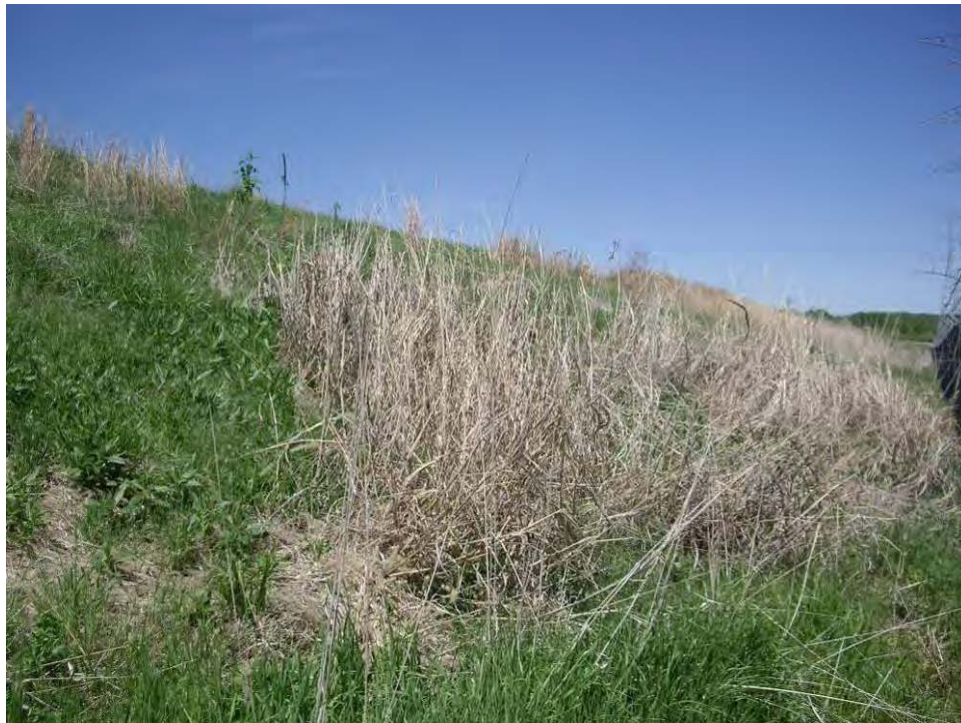
A possible former seep area was observed at the toe of the east embankment (Photo 12). IPL indicated that the conditions observed in this area were the result of an ash sluice line leak. A possible former seep was also observed in a soft spongy area along the toe of the south embankment (Photo 21). No active seepage was observed during the site visit. However, active seepage in these areas has been noted in previous inspection reports.

12. Pond A looking north - Possible former seep location at toe of east embankment.,.

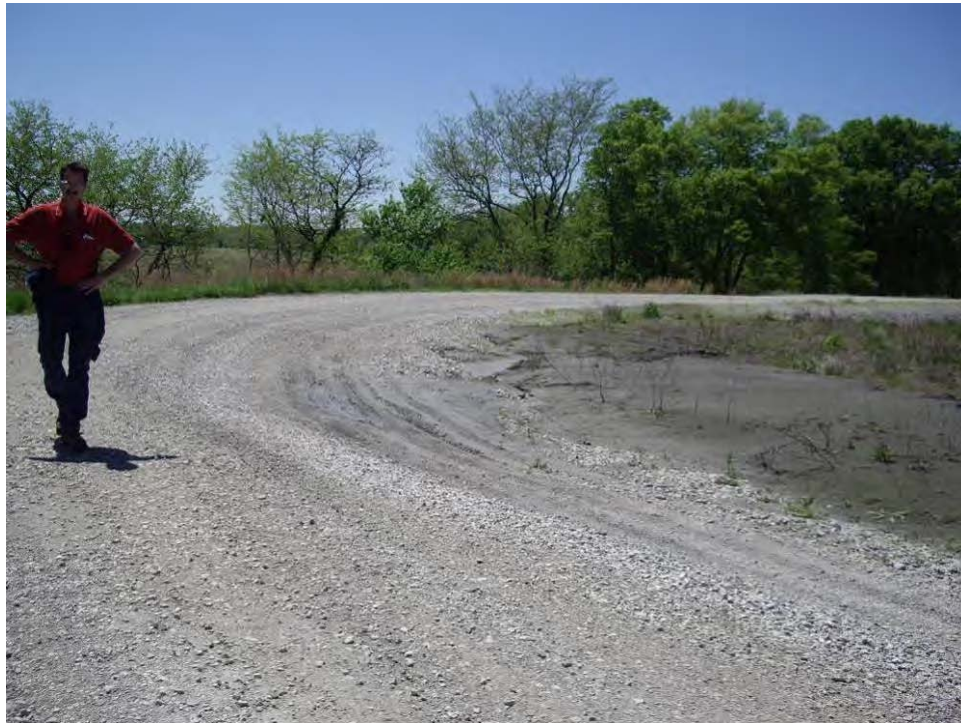
14. Pond A - Depression in crest from truck traffic, looking south.

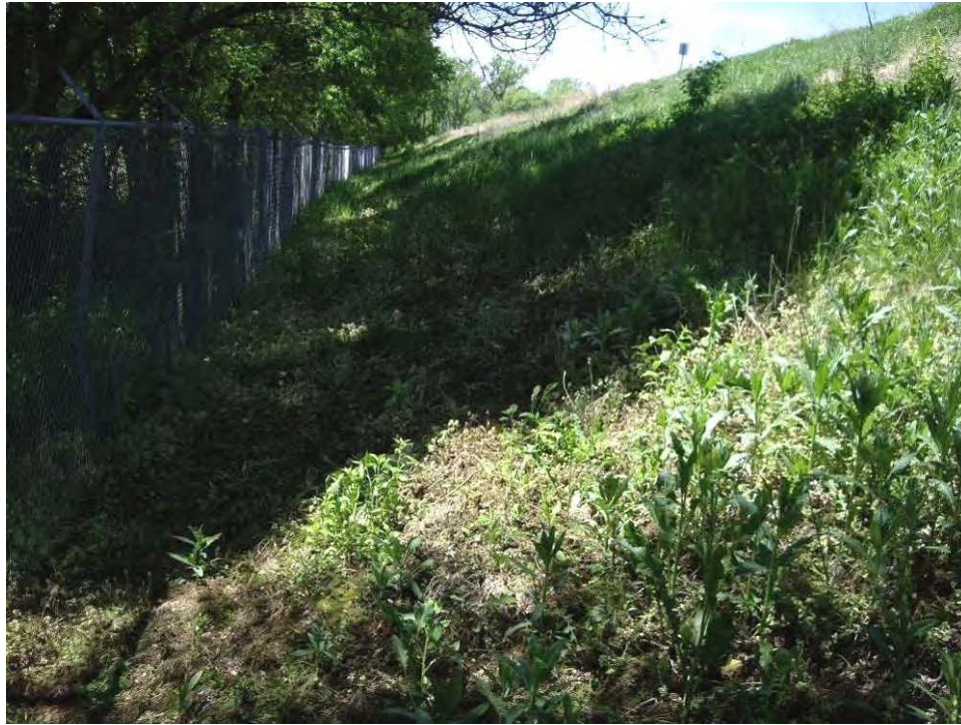
21. Pond A – Soft spongy area at toe of south embankment under tree canopy (possible former active seepage area).

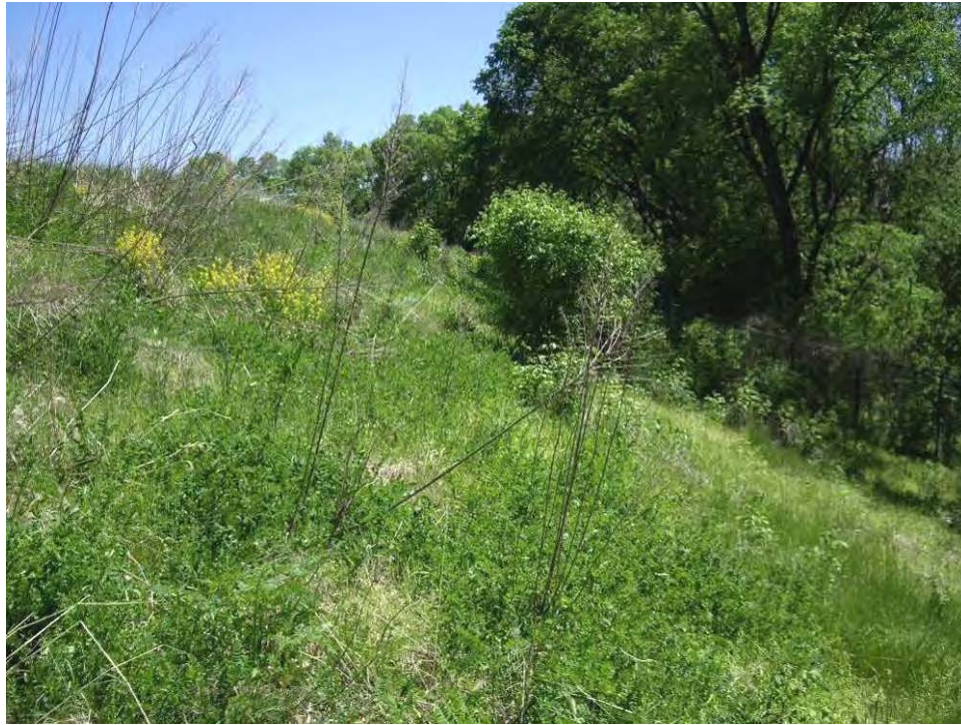
The north, south, east, and west embankments were generally covered with grassy vegetation approximately 12 to 48 inches tall. There are multiple species of grass growing on the slope from the various expansions and erosion repairs. There was some small brush on the southwest embankment (Photo 23) and one bush growing on the east embankment.

23. Pond A – South embankment exterior slope, looking southeast.

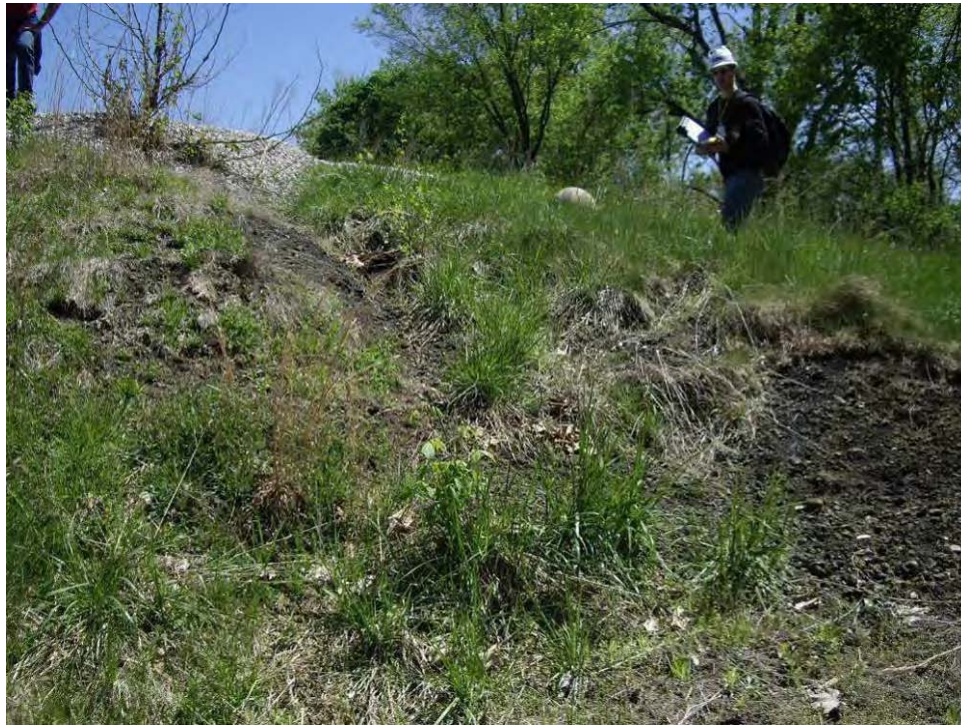
26. Pond A – Erosion rill on west embankment exterior slope, looking east.

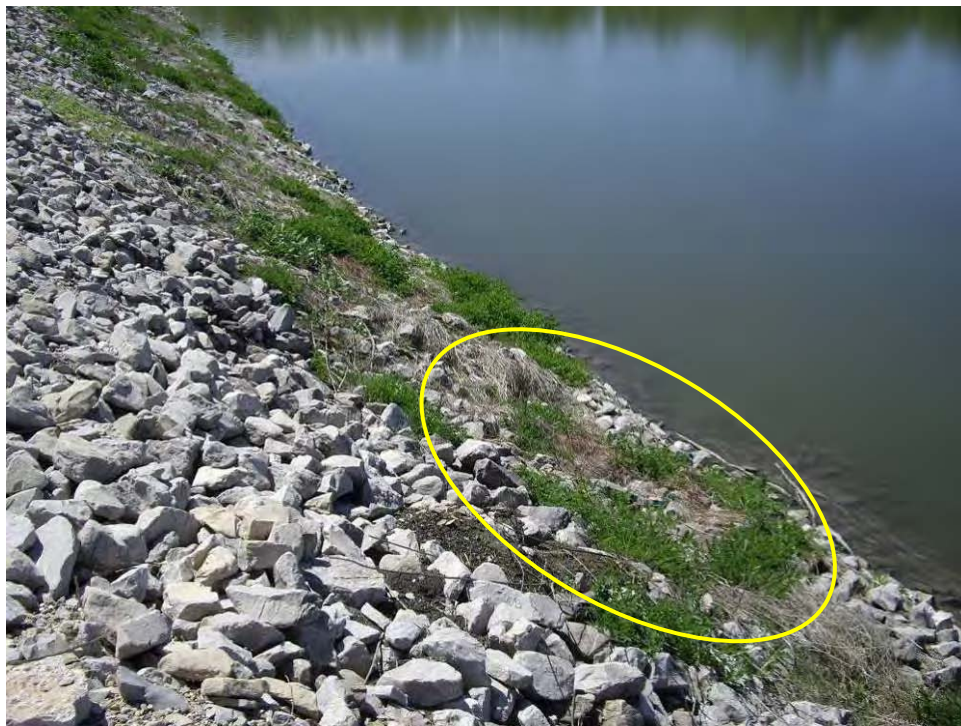
32. Depression in north slope of Pond A/B divider embankment.

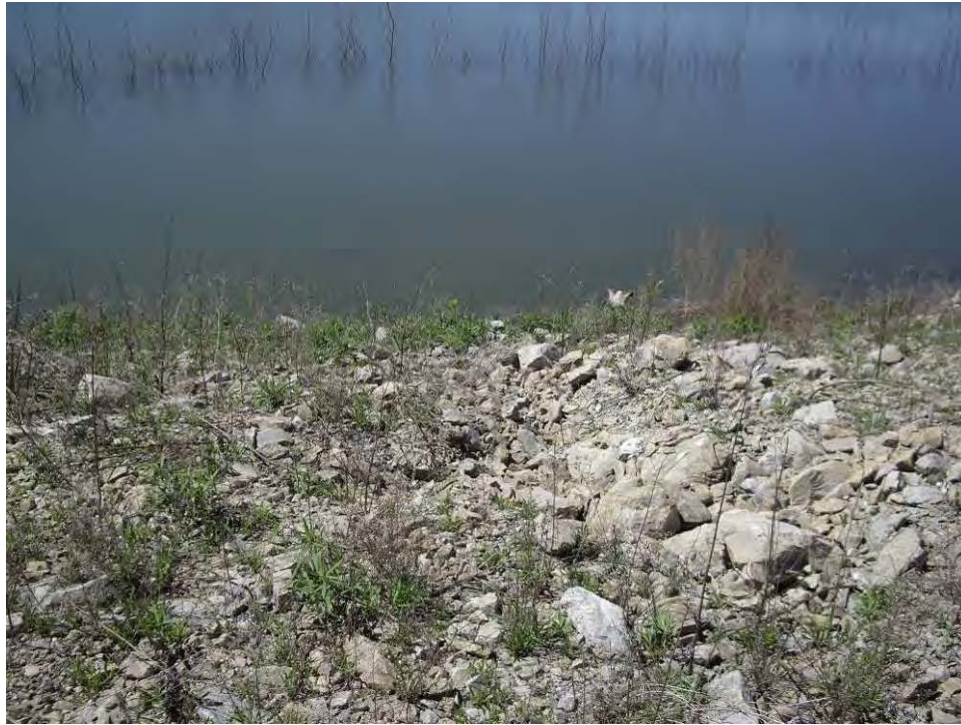
35. Erosion feature and depression in north slope of divider embankment A/B.

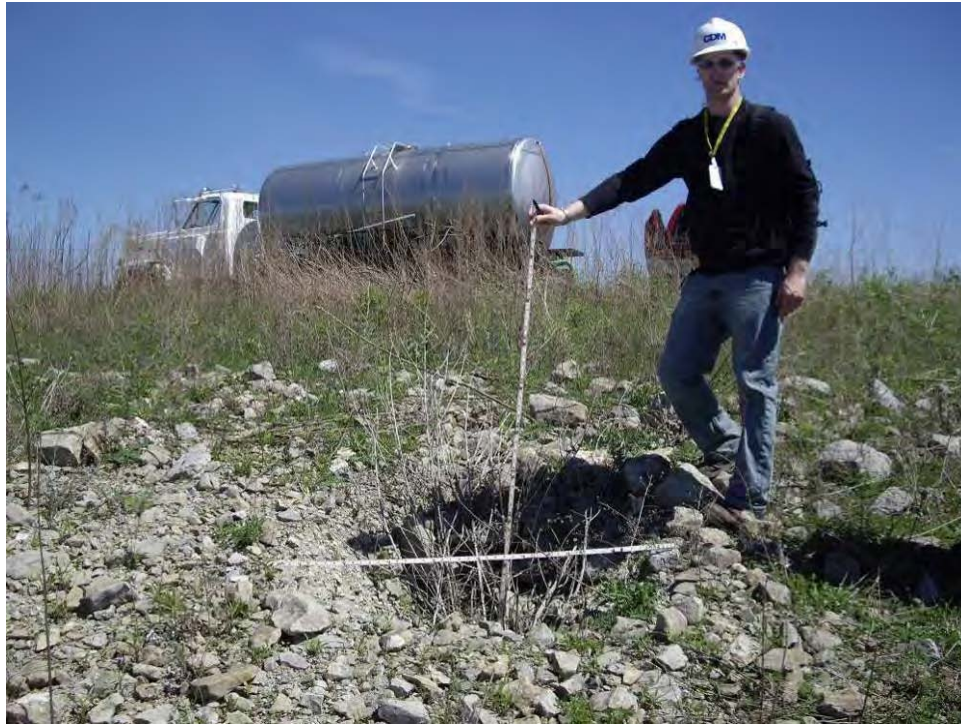
37. Depression in northwest slope of divider embankment A/B.

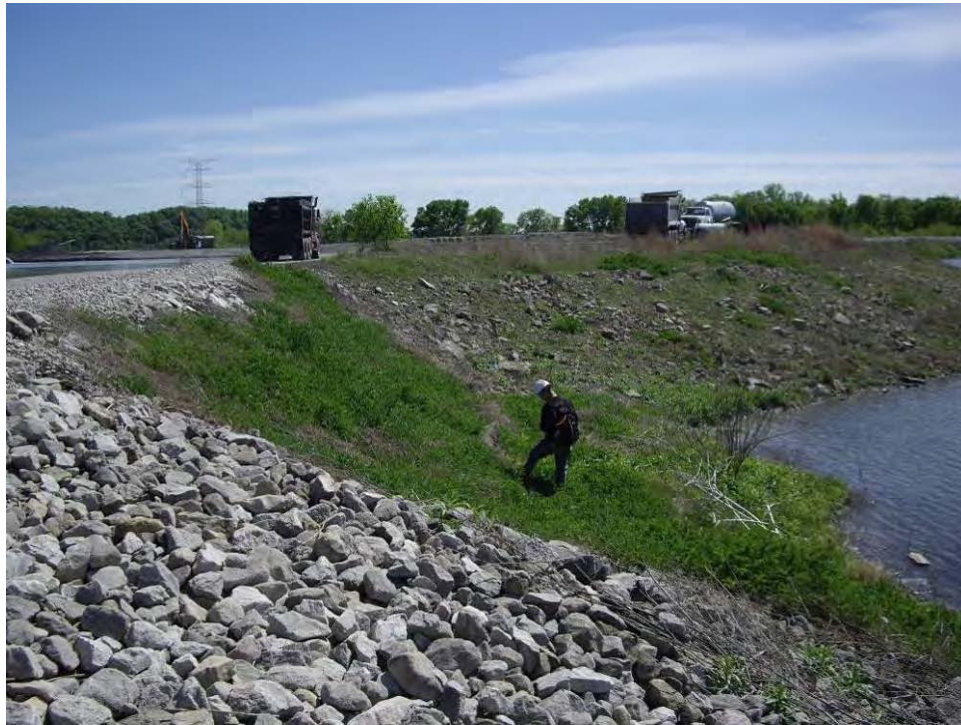
The exterior slopes on the divider embankments A/B and A/C were generally protected with riprap or crushed stone armor. Some areas were not armored and were covered with vegetative protection. Some erosion features, surface depressions, and minor sloughing were observed on the slope (Photos 32, 35, 36, 37, and 38). Some of the larger surface erosion areas appeared to have been recently filled with riprap or

stone (Photos 38, 40, 41, and 42). IPL indicated that the erosion was the result of heavy rainfall in the summer of 2008 and was repaired in June 2008. There was also some brush and small trees growing at the toe of the divider embankment in Pond C (Photo 42).

38. Northwest slope of divider embankment A/B, looking south.

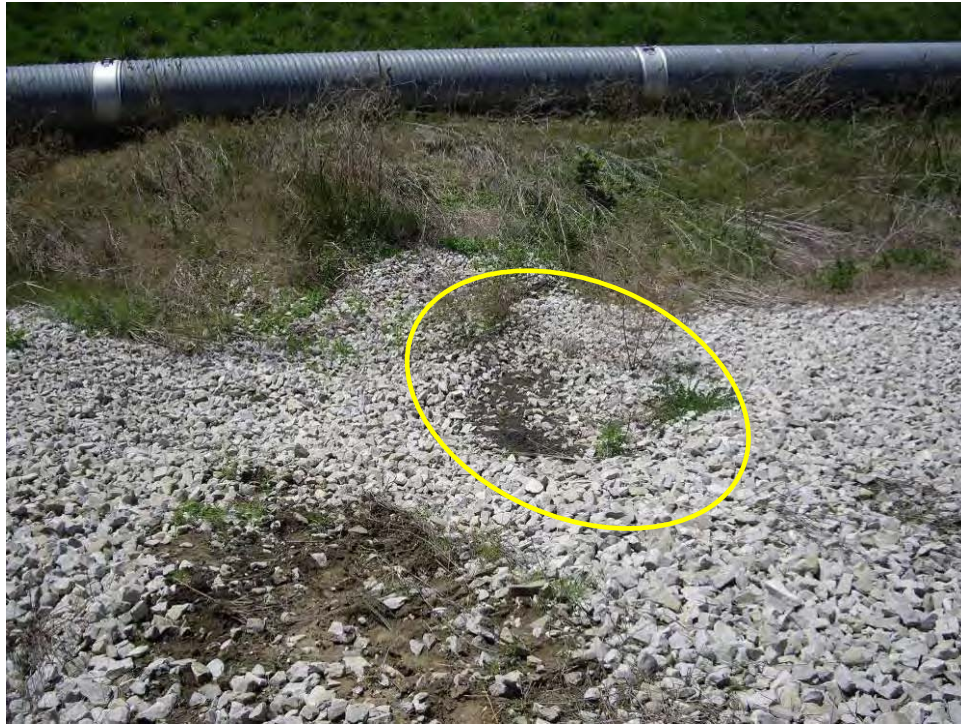
41. Minor sloughing and erosion feature on west slope of divider embankment A/C.

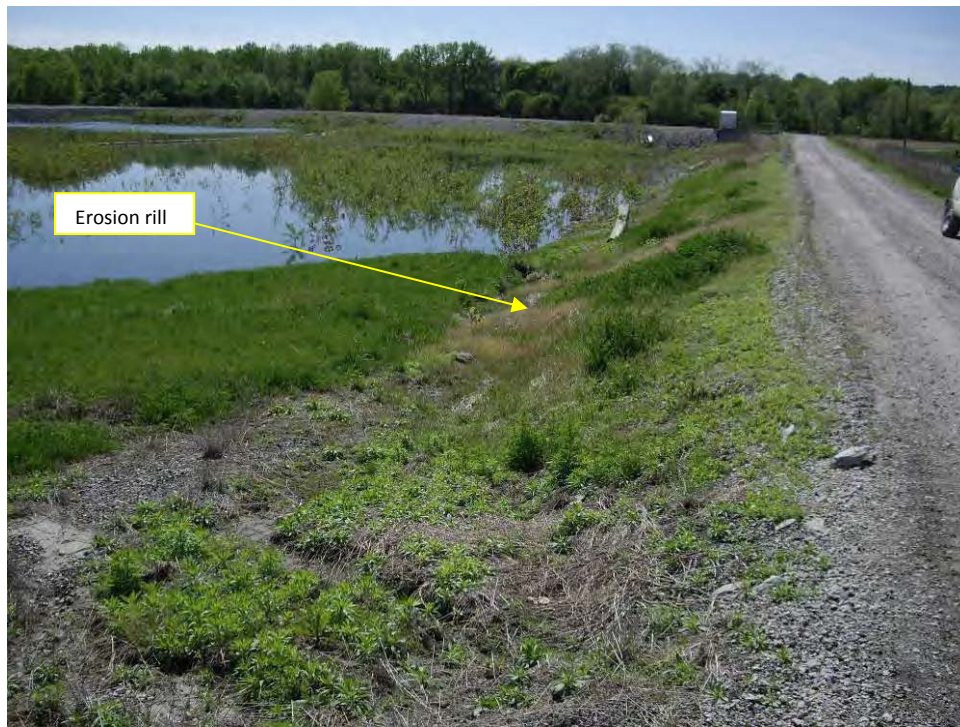
47. Pond C – North embankment interior slope and crest, looking west. Note erosion rill on interior slope.

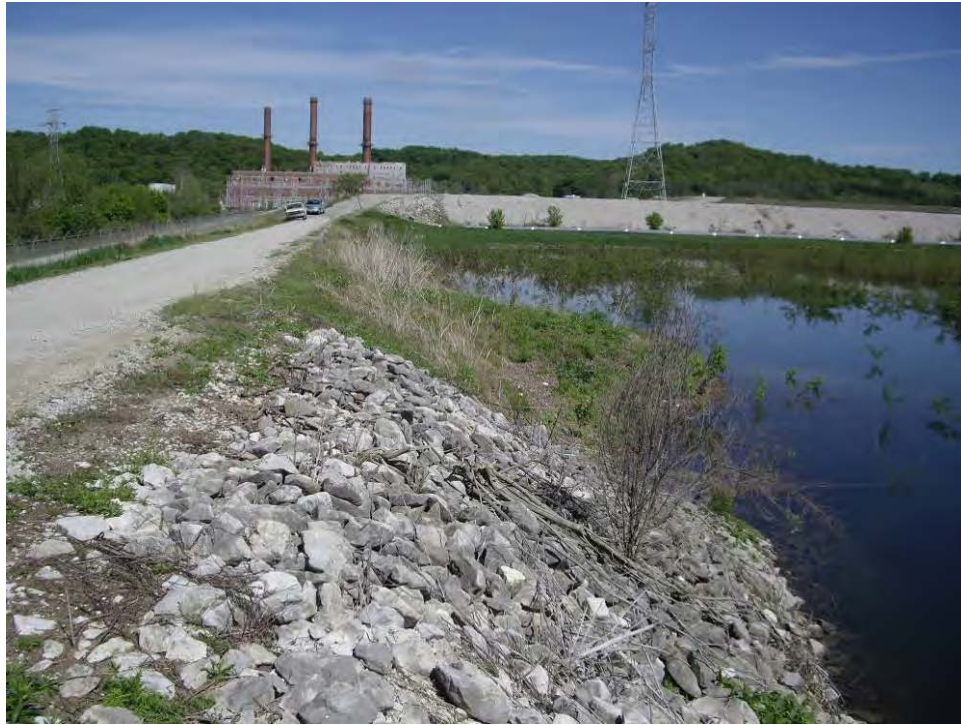
49. Pond C - North embankment interior slope, looking east. Note brush and limited riprap on slope.

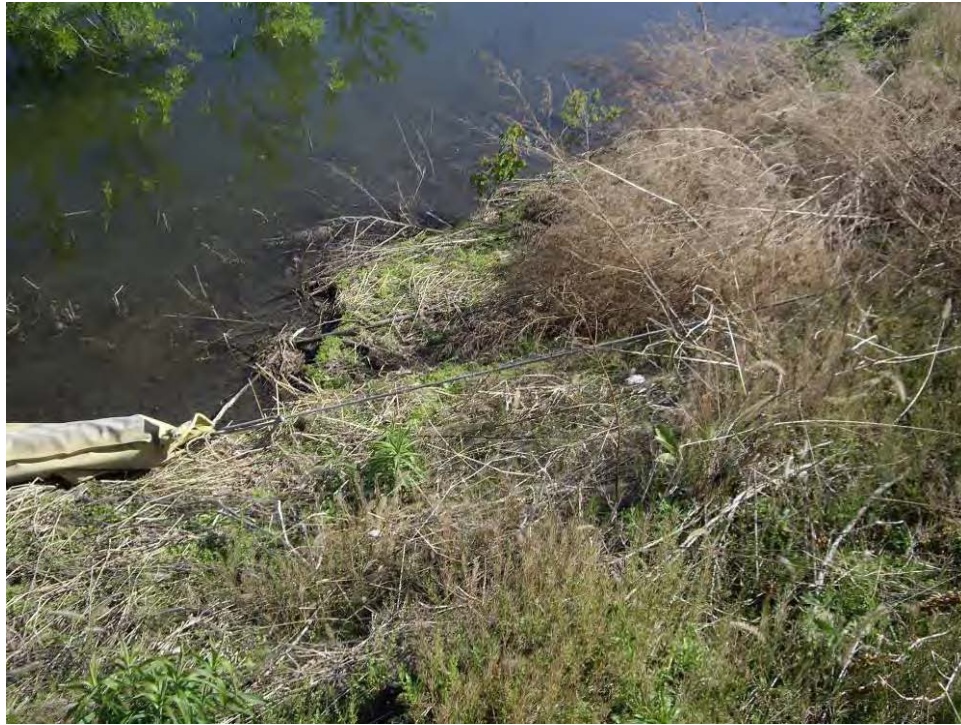
55. Pond C – Erosion feature from diversion boom tie line.

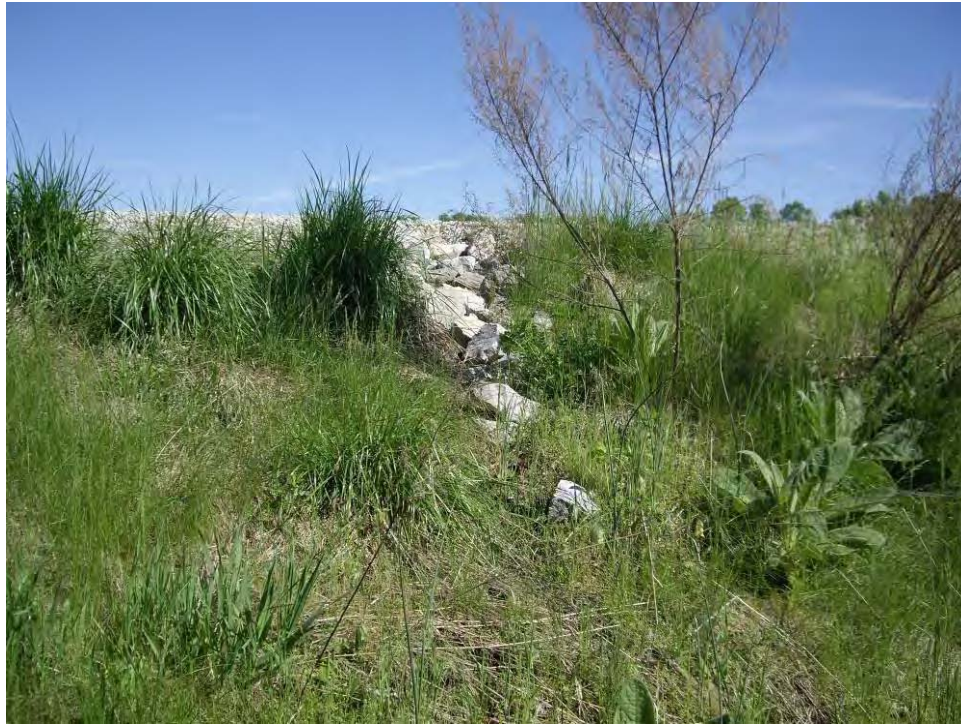
An erosion rill on the exterior slope at the southern reach of the west embankment was observed (Photo 65). The erosion rill had recently been filled with riprap to reduce further erosion. Another erosion rill was observed on the west embankment (Photo 26). Some crushed stone was placed near the crest of the embankment in an effort to reduce further erosion.

65. Pond B - erosion rill on exterior slope recently filled in with riprap, looking east.

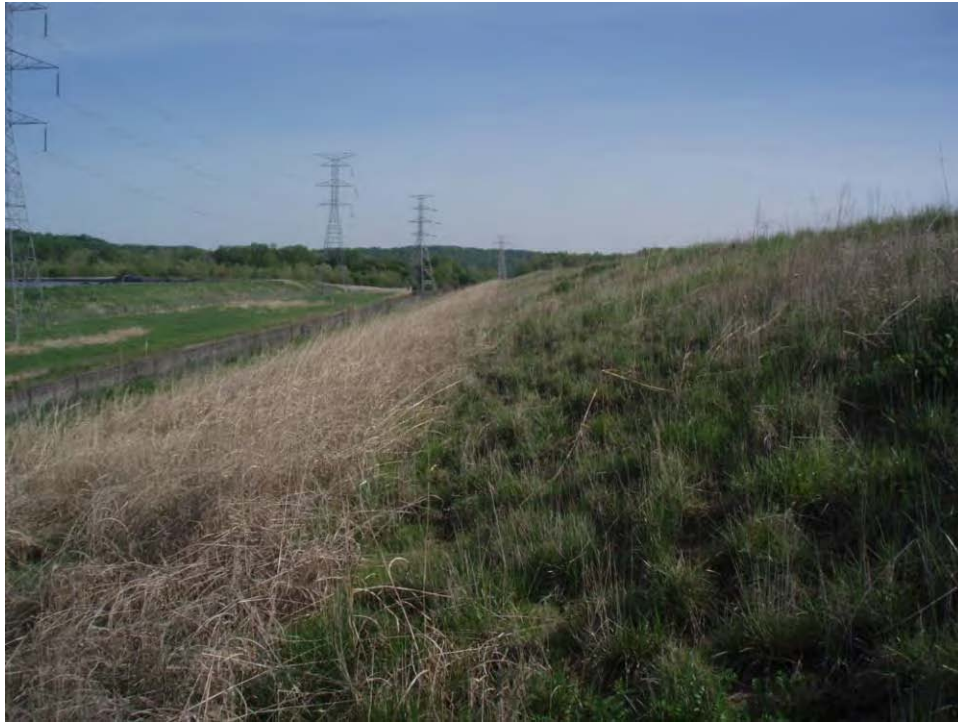
89. Pond D – West embankment exterior slope, looking north. Note bands of vegetation from the vertical expansions. Bare spots observed on upper third.

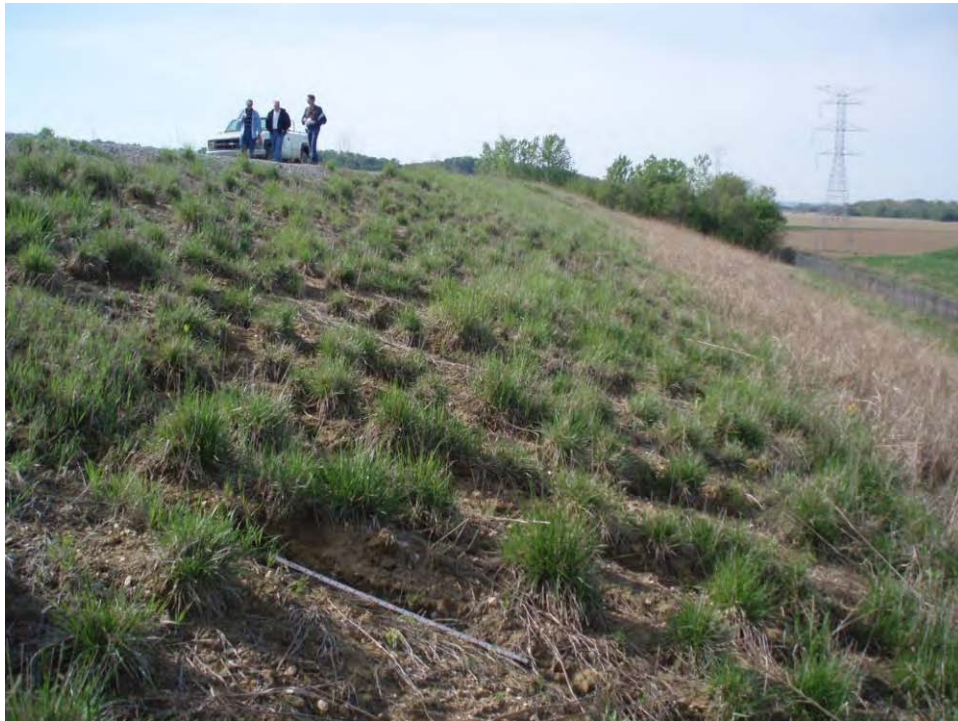
90. Pond D – Typical bare spots on upper third of west embankment exterior slope, looking south.

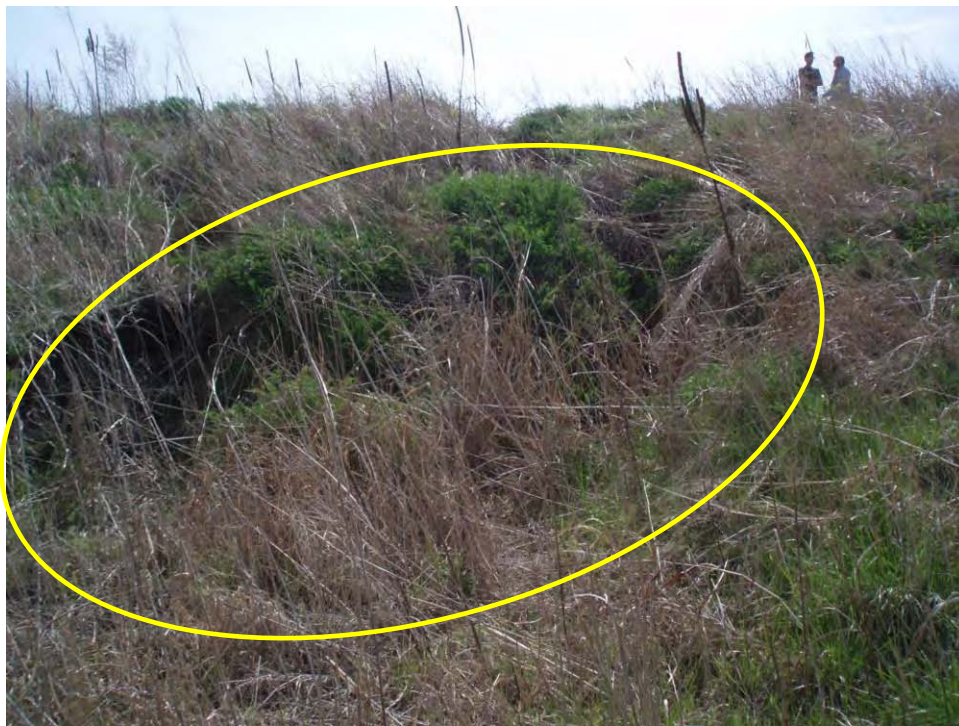
106. Pond E - 16'Wx4'Dx17'L erosion gulley at toe of west embankment exterior slope from previous failure event. Note erosion is scheduled to be repaired.

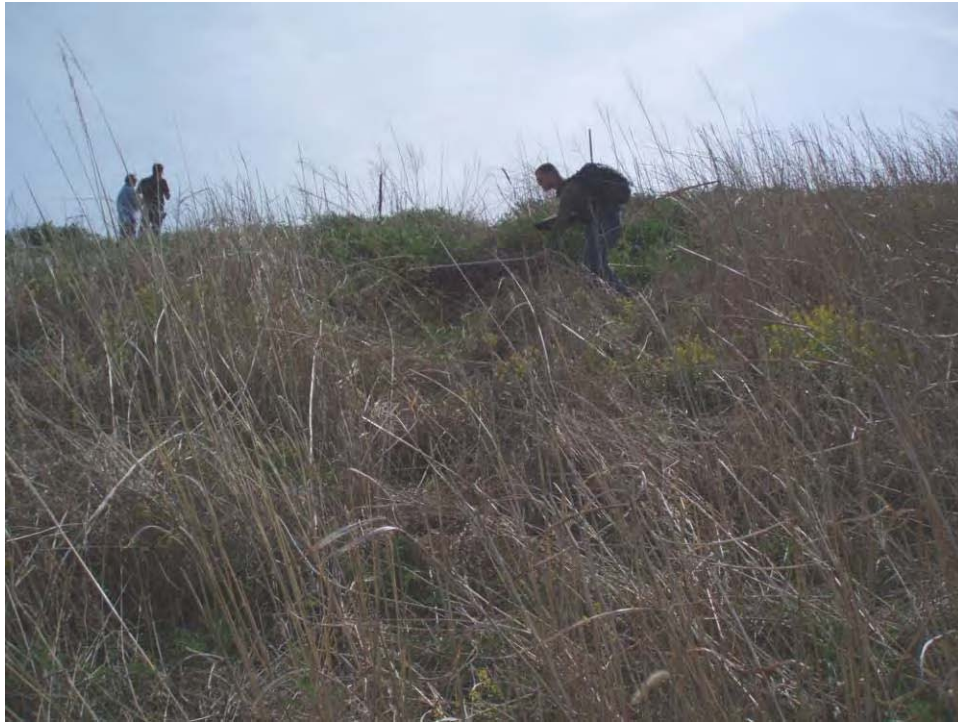
107. Pond E – 8'Wx4.5'Dx15'L erosion gulley at crest of west embankment exterior slope from previous failure event. Note erosion is scheduled to be repaired.

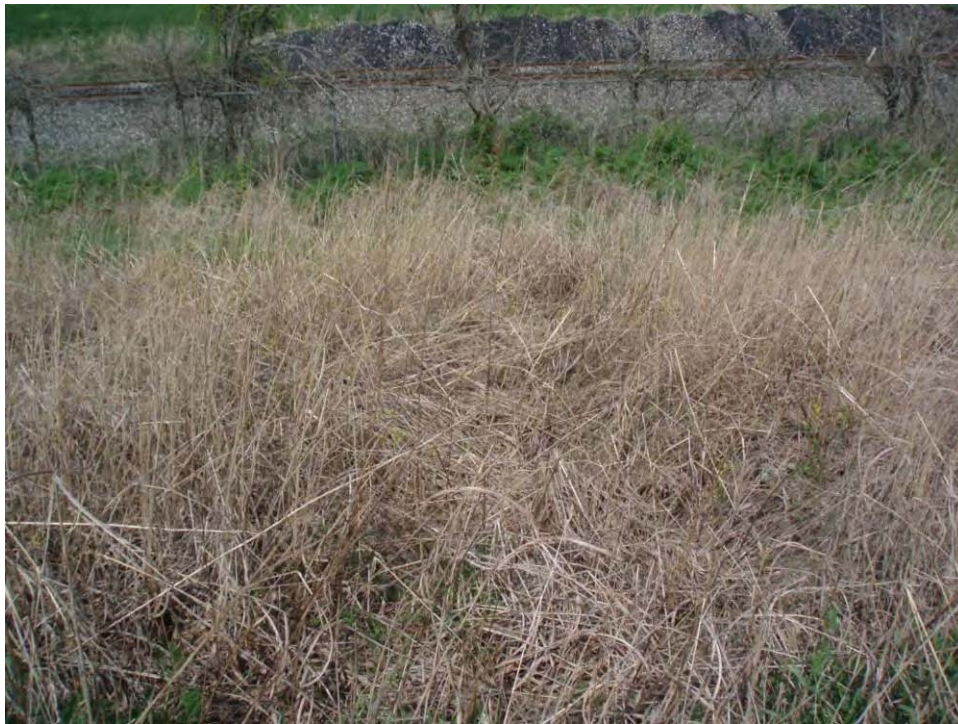
112. Pond E – 8'Wx3'Dx25'L erosion gulley at mid-slope of west embankment exterior slope from previous failure event. Note erosion is scheduled to be repaired.

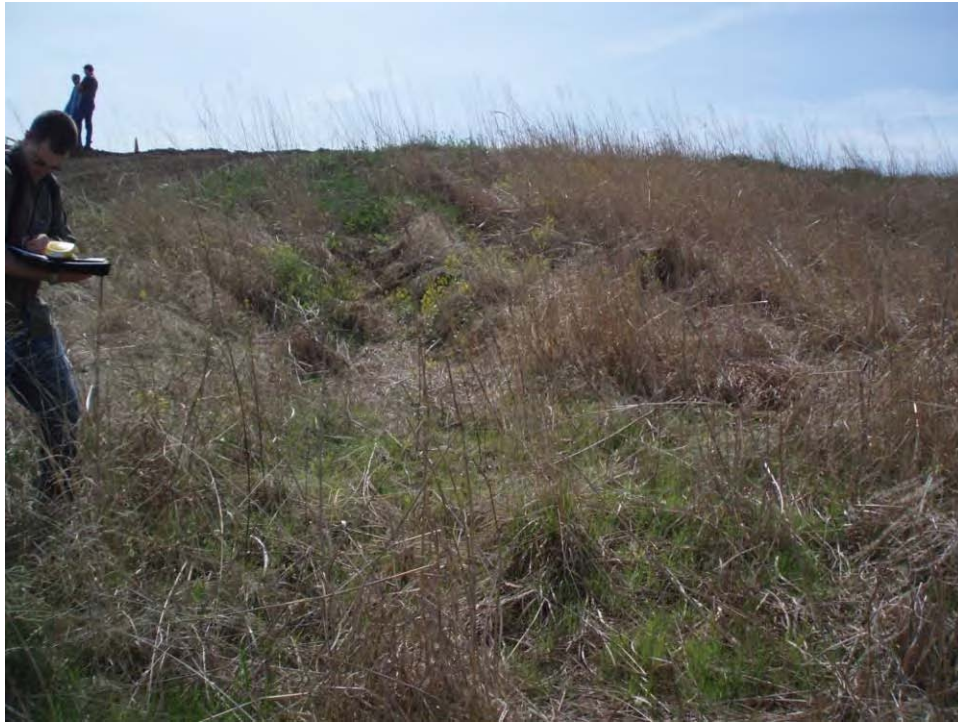
113. Pond E – two approximately 4'Wx3'Dx20'L erosion gulleys at mid-slope of west embankment exterior slope from previous failure event. Note erosion is scheduled to be repaired.

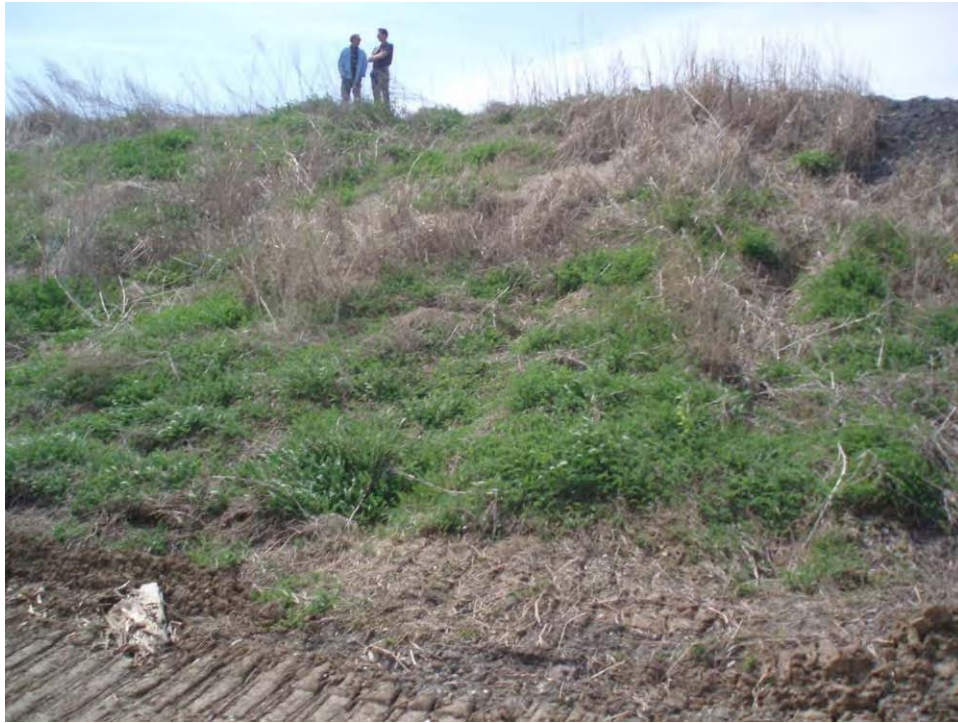
119. Pond E – erosion feature on north embankment exterior slope from previous failure event.

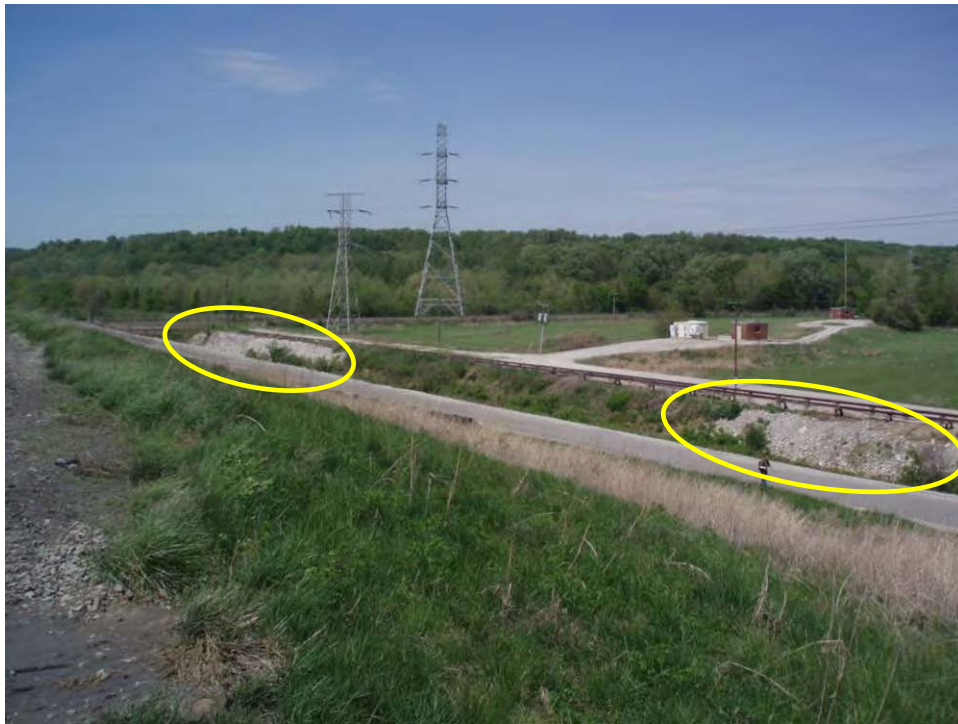
136. Overview of downstream area north of Pond D and Pond E. Note repair of erosion areas which resulted from breach.
